## **Apollo Vredestein measures tread depth while driving**

### **In-house laser tread depth measuring station unveiled, underlining company's emphasis on safety and the environment**

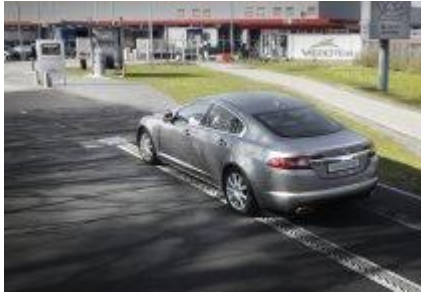
View on the measuring site in Enschede (NL)

The laser tread depth measuring station was developed by Procontour for police applications and large car fleets. It measures the tread depth with a laser whenever a car drives over a grid with measurement tools in the road surface. The system is capable of performing 35,000 measurements a minute and gives accurate figures at speeds of up to 120 km/h. It is equipped with a sensor and compressor that ensure that the grid is blown clean whenever a car approaches to allow the laser to take measurements. A matrix sign then indicates the

tread depth of the tyre with the least tread. In the long term Apollo Vredestein aims to use the system at the facilities of business partners and at large events or locations that feature a large number of cars. The ultimate goal is to raise
